# How to Cut Emissions & Fuel + Increase Capacity in Fired Heaters

## How to Cut Emissions & Fuel + Increase Capacity in Fired Heaters

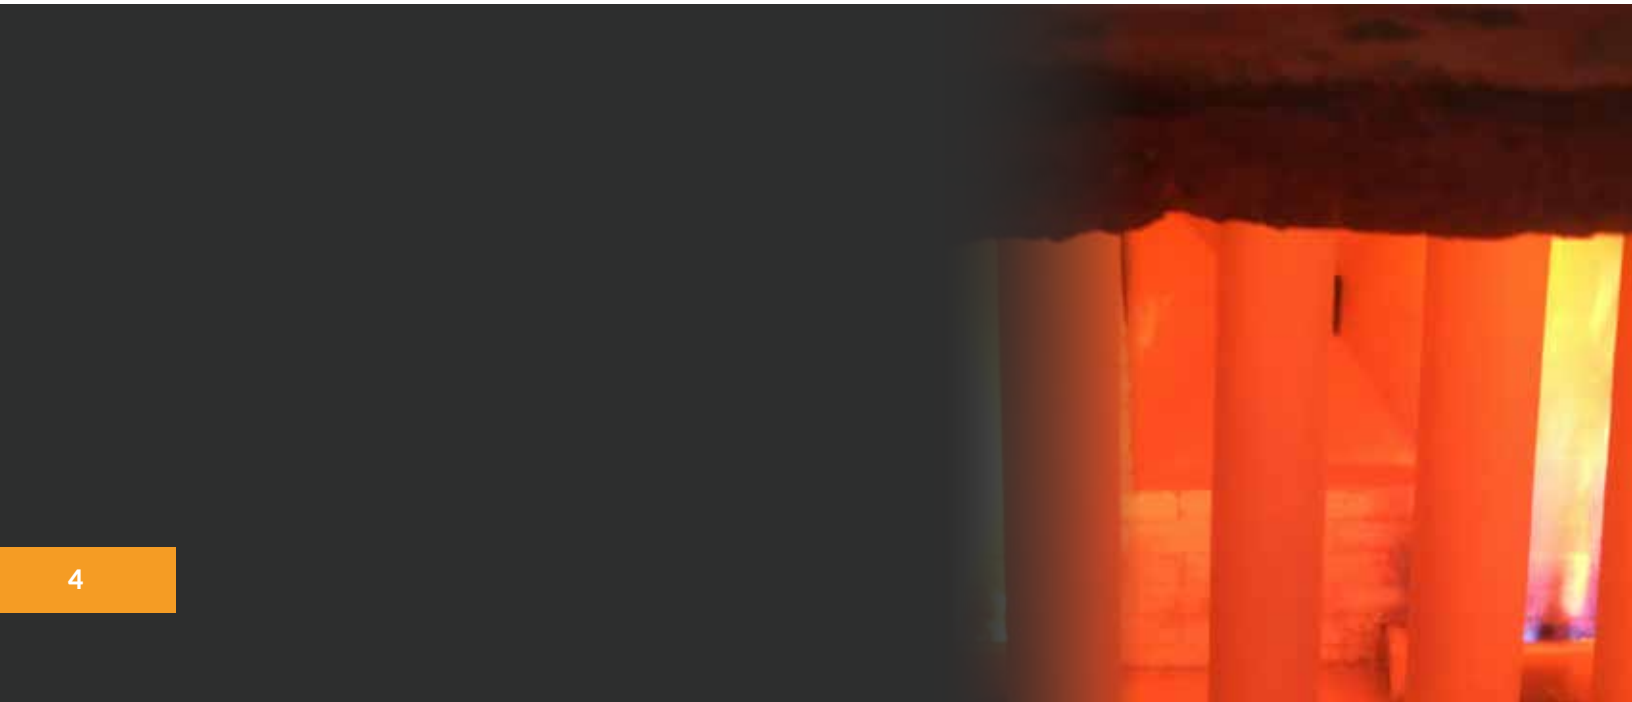
In use, the steel alloy tubes oxidize, and layers of scale grow continuously over time on the external surfaces. The developing scale insulates the tube surface, hindering conductive heat transfer to the process and decreasing radiant section efficiency.

To overcome the insulating effect, extra heat is needed and firing rate is increased. This results in increased flue gas temperature (bridgewall temperature). Consequently, CO<sub>2</sub> and NO<sub>x</sub> emissions are increased. As scale grows and further increases in firing rate are required, BWT limitations are encountered, and production rates are threatened.

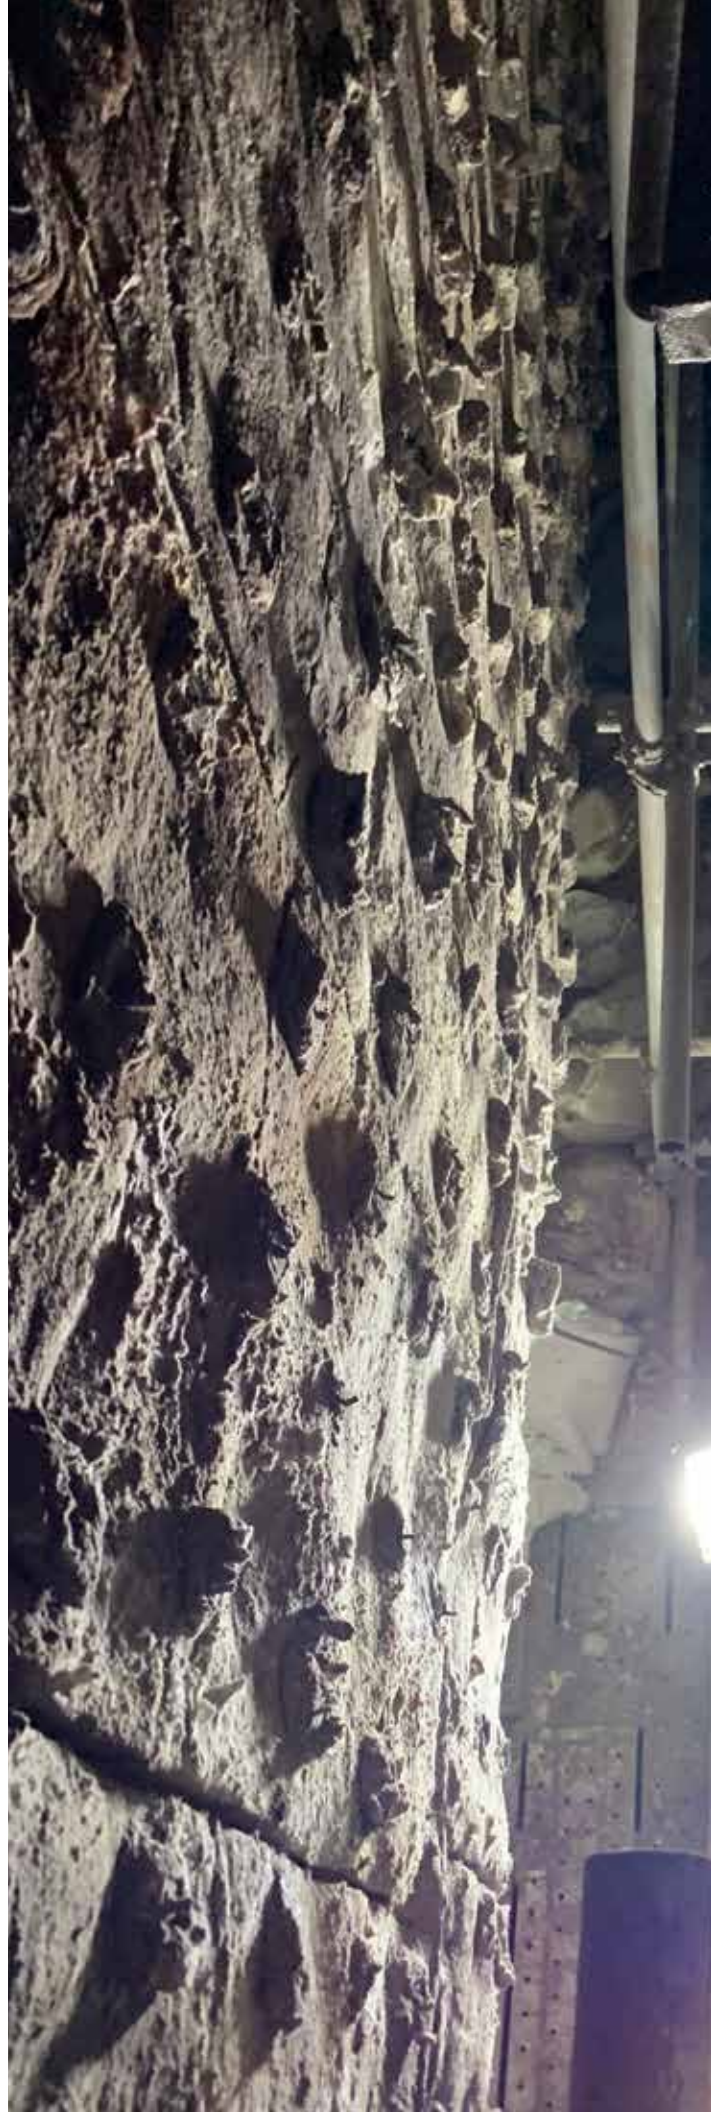
Cetek Ceramic Coatings with emissivity values of above 0.9, have been designed specifically to supplement the radiation characteristics of the refractory surfaces. In use, benefits have been realized of up to 5% in radiant section efficiency improvement, with corresponding CO<sub>2</sub> emission reduction up to 5% and NO<sub>x</sub> emission reduction in Ethylene and SMR up to 30%.

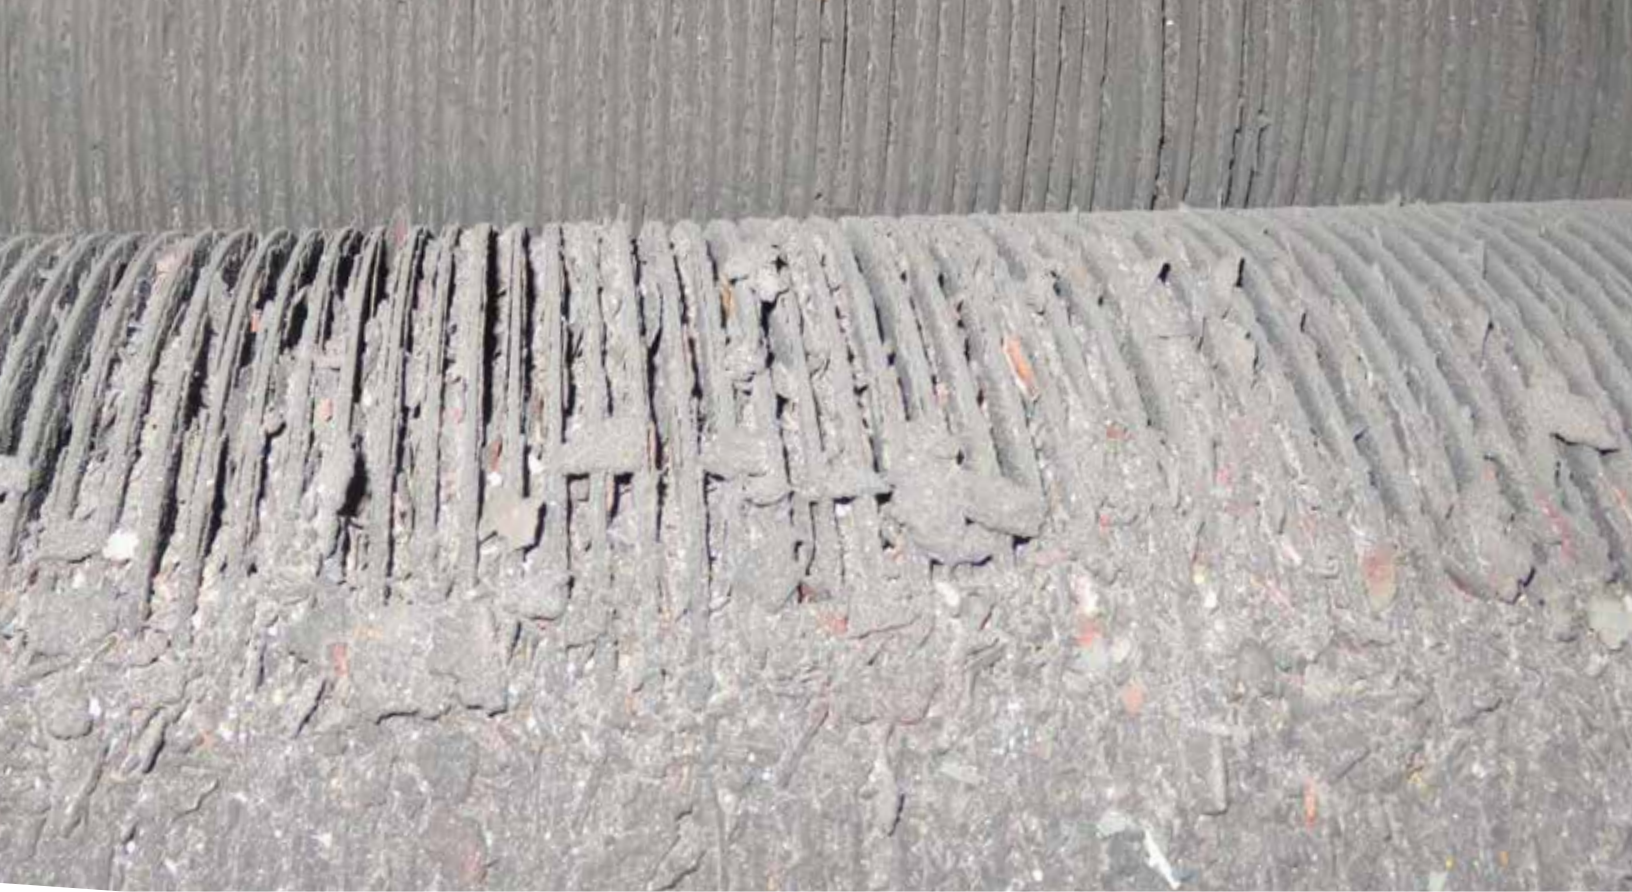
Fouling occurs when deposits accumulate on the tube or fin surfaces. The burner alone is designed to operate with one part per million airborne particulate. This means that a single burner can pass 2.5 tonnes of debris through a heater in a year, some of which will deposit.

There are two commonly used offline cleaning methods to tackle the issue of fouling: chemical and dry-ice blasting.

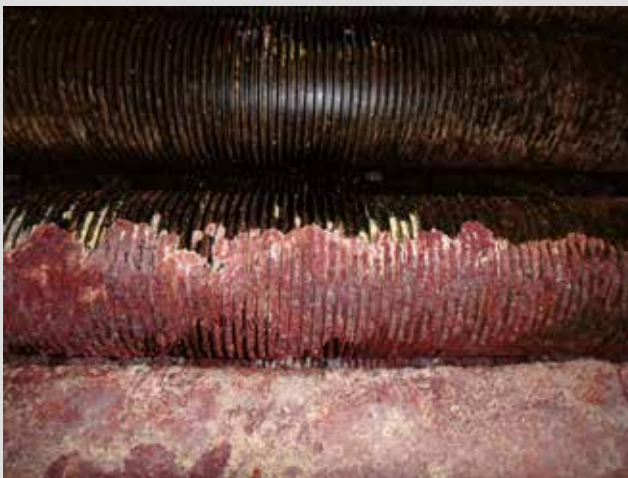
**BEFORE** - Heavy Fouling  
on a Convection Section

## How Does Fouling Occur?

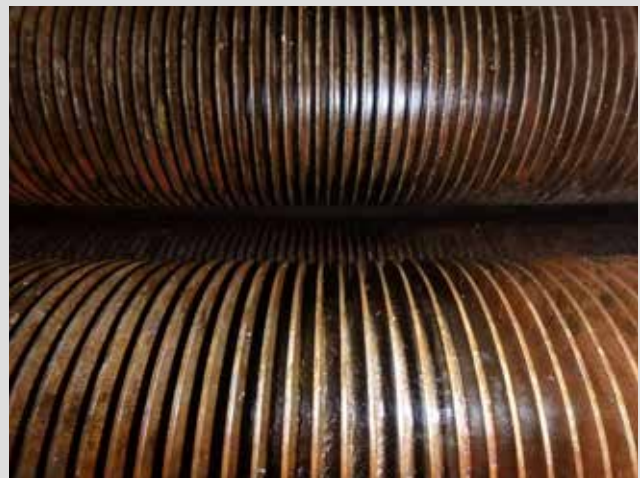
**AFTER** -Convection Section  
Robotically Cleaned

A comprehensive solution is offered by **Tube Tech**, an IGS Solution, which uses robotic cleaning systems to clean more than 90% of convection section tube fouling during planned turnarounds.
